HISTORY OF FACADE COLOURS

## THE CHANGING COLOURS OF COPENHAGEN

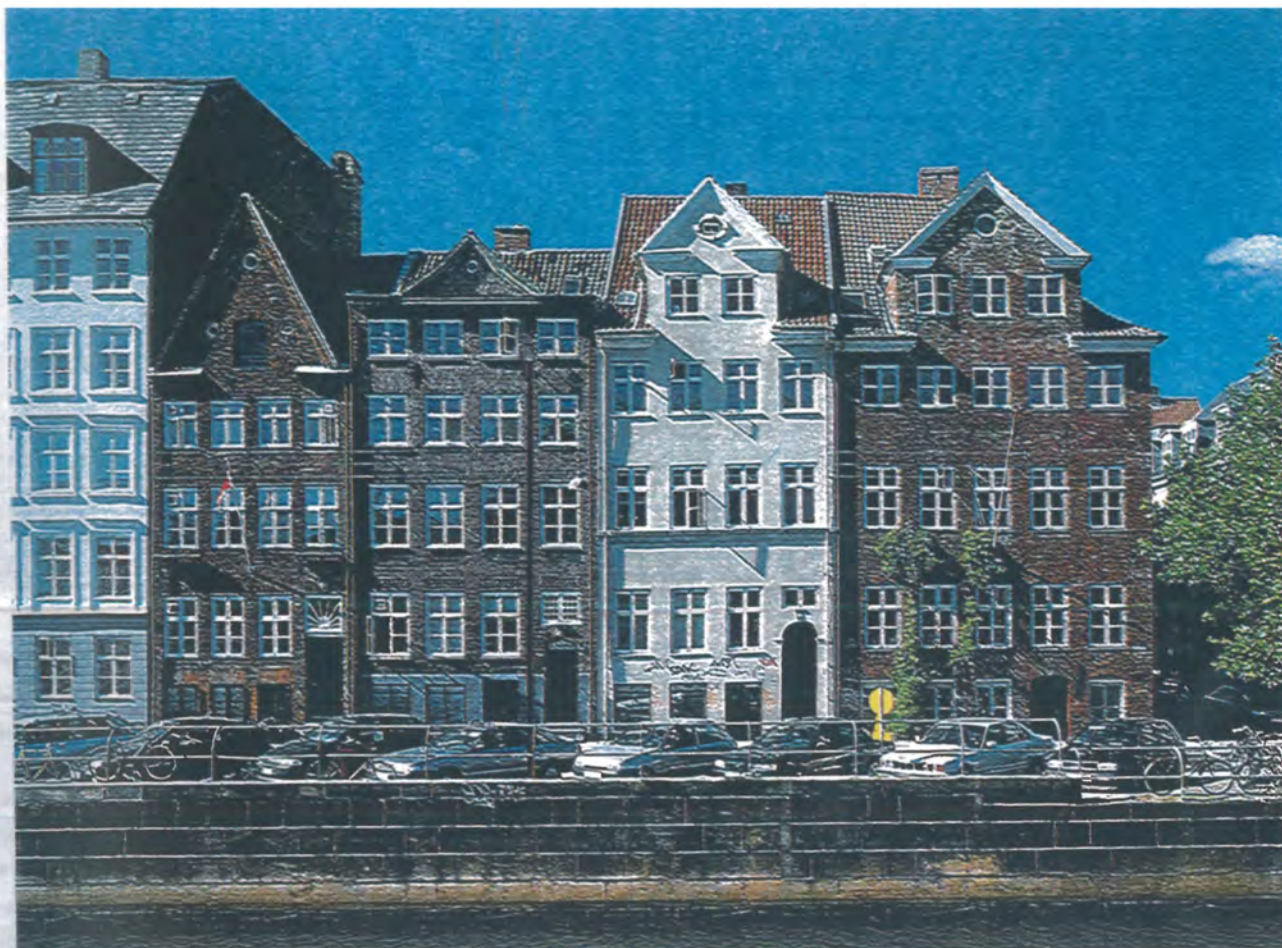
Fig. 23. The gabled brick-masonry buildings of Nybrogade were erected after the great fire in 1728.

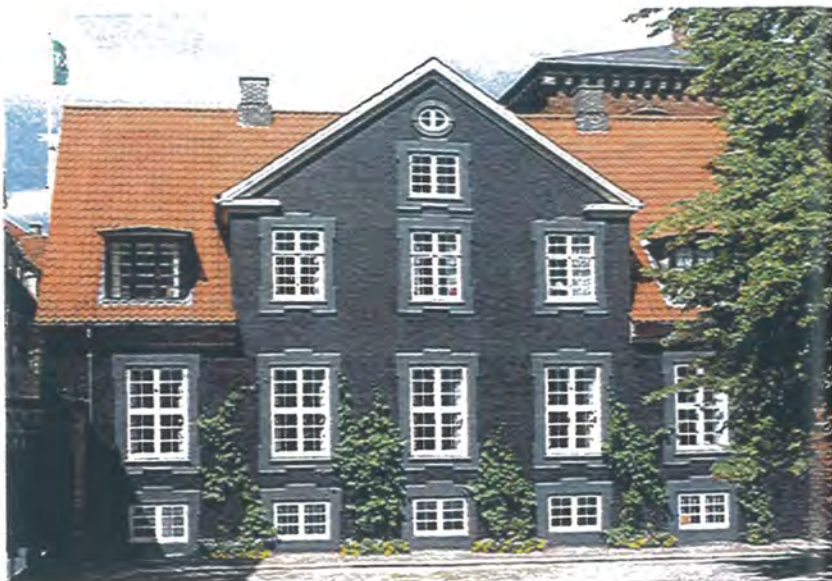
Fig. 26. Krieger's drawing of a model house after the fire in 1728.

Krieger worked out a set of model designs with specifications and cost estimates, and put them in a fine little book entitled *Berechnungen und Dessenins auf 3 differente grandgemauerte Gebäude* (Calculations and Designs of Three Different Solid Brick Buildings). See Fig. 26.

The facade drawings were made as engravings with hatched surfaces, light frames and cornices; the base and some of the pediments are illustrated with dots. What do these symbols mean? Unfortunately, masonry treatment is not described further, nor are the specifications that accompany the drawings, which indicate that the base and chimney were of reused brick: "*Steine von denen niedergeschlagenen und abgebrannten Mauren*"<sup>25</sup>.

However, it is probable that the facades were of exposed masonry, as reused brick was only indicated for non-visible masonry. If the intention had been to render the facades, reused brick could have been used throughout. The cornices and base moulding must have been executed in sandstone - they are referred to as *Gesims Steine* and *Corniss Steine*, while the window surrounds may belong to the ornamentation executed in dressed or moulded brick. Probably any brick used in cornices or window surrounds would have been stuccoed and presumably painted grey to imitate sandstone. The dotted base could have represented dressed granite, but as granite is not mentioned in the list of materials, and the same symbol is used on part of the pediment, it is more likely to have been stucco. Thus, we must assume that Krieger designed his model house for execution in exposed masonry with brick window surrounds, perhaps cement washed or painted grey to look like sandstone; cornices and mouldings were envisioned of genuine sandstone.

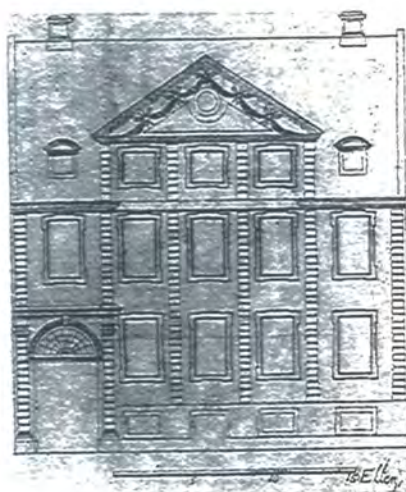
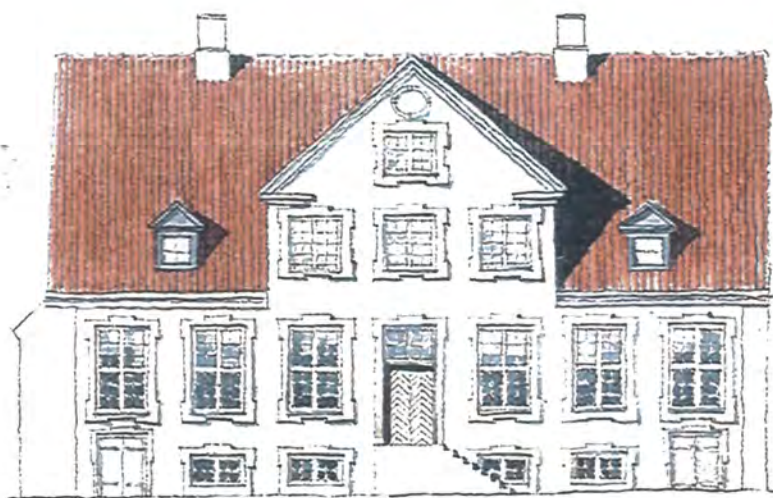
Fig. 24-25. No. 8-10 Nørregade. Krieger is believed to be the architect of this building, once a professor's residence. It was built in 1730 of reused brick and the facades were therefore rendered and white-washed. The brick surrounds of the doors and windows were coloured grey, perhaps to resemble sandstone.

Fig. 25. Reconstruction of the original colours of the facade.

No buildings were constructed exactly according to Krieger's model drawings. However, it is possible to find his ashlar pilasters, irregular window frames and festoons in the city, although not together on one facade (Figs. 24, 25 and 27)<sup>26</sup>. Krieger's drawings were used as a source of inspiration, although results were more modest, including some half-timbered versions.

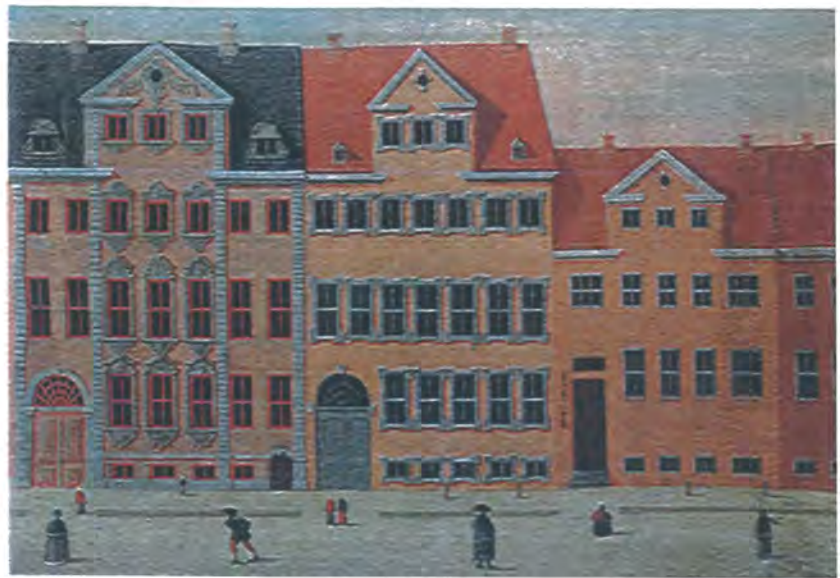
Fig. 27. Strongly influenced by Krieger's model drawings, master cabinetmaker Mathias Ortmann built no. 41 Gothersgade as his own residence and workshop in 1733. It was here he built his ornate Baroque commodes. In 1749, Rach and Eegberg showed a red building, presumably of red brick with red windows and decorative elements in sandstone colour. A storey was added in 1829, and the facade ornamentation removed.

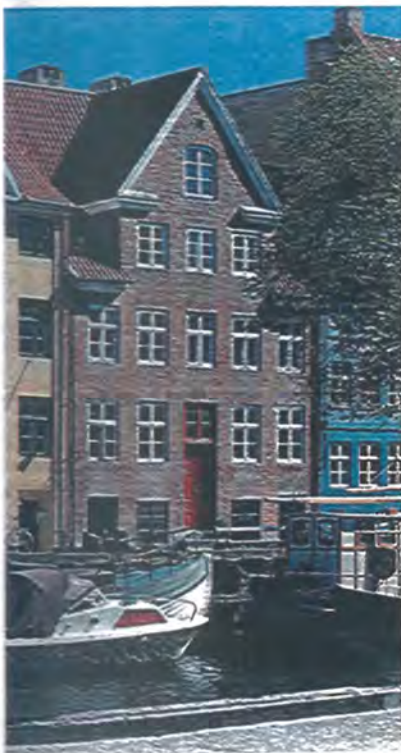
Fig. 28. No. 24 Overgaden oven Vandet, built before 1732, is reminiscent of Krieger's model drawings. The English bond masonry of the lower-storey was striped red and yellow. However, from the very beginning, the facade was painted over in red oil, perhaps some type of composite paint. Traces of it can still be seen.

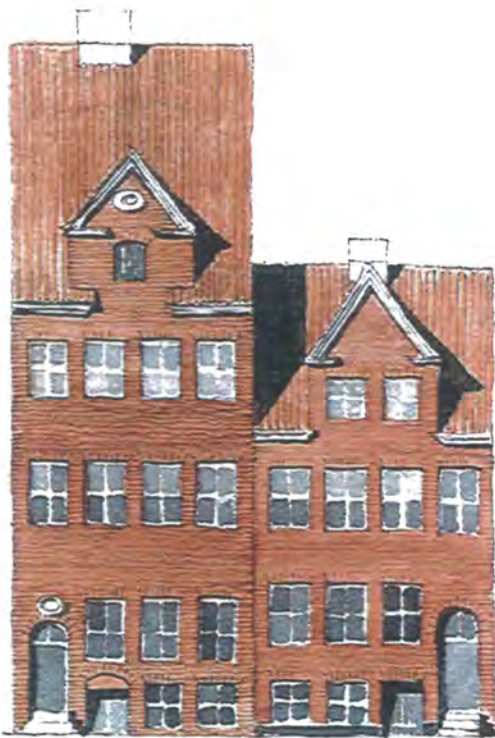
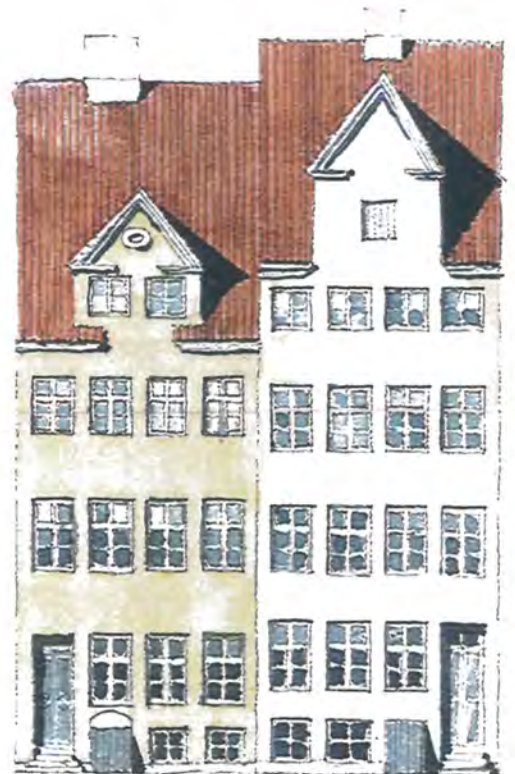
Fig. 29-30. No. 7-9 Gråbrødretorv. Reconstruction of the original colours of the facade. The design and colour of the windows is not known.

Fig. 29. The facades in 1729.

Fig. 30. A storey was added to no. 9 in 1779, and the facade given a colour wash. In 1847, records indicate that the facade had been given a coat of oil paint. The colours of the windows and doors shown here are based on assumption.

The new buildings, which were called 'fire houses', were narrow, about four to five bays wide, and two or three storeys high, usually with a cellar (Fig. 29). Although their roof ridges were parallel with the street, many of the buildings resembled gabled houses due to their full-width attic facades. These false gabled houses are peculiar to Copenhagen (Fig. 31)<sup>28</sup>. The infill between the half-timbering was of rendered brick, after which both brick and half-timbering were washed in bright colours. Emphasising the half-timbering by painting it a different colour than the masonry was probably not common, as no one would have wanted to call attention to this cheap, old-fashioned method of construction. The mullioned windows had small panes containing inexpensive greenish glass. Cellar windows had shutters, while the ground floor often had interior shutters. In buildings of brick masonry construction, relieving

The south side of Gråbrødretorv has one of the best rows of buildings from the years immediately after the fire of 1728<sup>30</sup> (Fig. 31). If we are to believe Rach and Eegberg, many of the facades around the square were red. However, we cannot see from the painting whether the buildings were of red masonry or red-washed stucco. A colour analysis of no. 9 disclosed that the facade was originally of red brick, later given a wash of light yellow. A colour analysis of no. 7 showed a layer of grime on the red masonry, followed by a yellow layer, presumably a coat of wash. Therefore, it is probable that the original facade was of red brick (Figs. 29, 30 and 32).

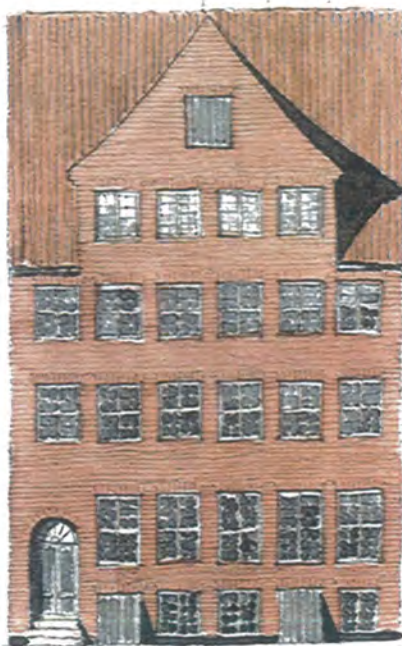
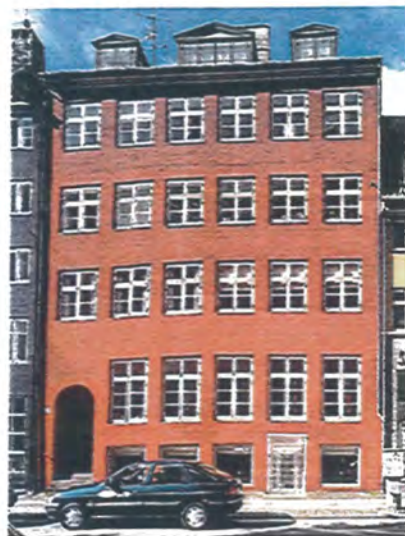
Fig. 33-35. No. 31 Gl. Mønt, built in 1732 of red masonry. It was not until a storey was added in 1831 that the facade was given a dark red colour, probably with composite paint. The windows were greyish white after the new storey was added. Shown are the original colour scheme of the building in 1732 (Fig. 33 - design and window colour are based on an assumption) and prior to 1831 (Fig. 34).

Several facades from this period were originally built of exposed masonry and were rendered later: for example, no. 31 Gl. Mønt, no. 11 Valkendorffsgade and no. 15 Wildersgade.

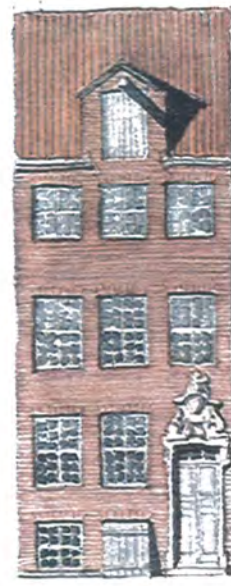
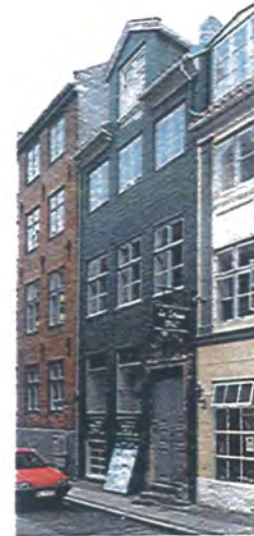
Fig. 36-37. No. 11 Valkendorfsgrde from the 1730s is an example of a modest, late Baroque house, built originally of exposed red-brick masonry with sandstone-coloured moulding and an ornate sandstone entrance. The building was later given a warm white coat of wash. The original window colour is not known.

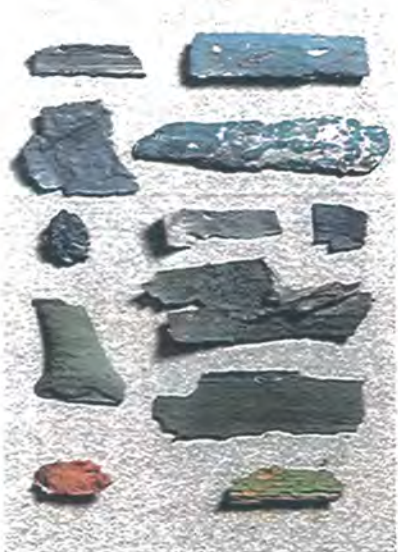
Fig. 190. Paint peelings from Copenhagen windows display a colourful past.
